Contract #: 04-0120F4Cty: SF/ALA Rte: 80 PM: 13.2/13.9File #: 1.28**WELDING INSPECTION REPORT****Resident Engineer:** Casey, William**Address:** 333 Burma Road**City:** Oakland, CA 94607**Report No:** WIR-028773**Date Inspected:** 21-Nov-2012**Project Name:** SAS Superstructure**OSM Arrival Time:** 700**Prime Contractor:** American Bridge/Fluor Enterprises, a JV**OSM Departure Time:** 1530**Contractor:** American Bridge/Fluor Enterprises, a JV**Location:** Job site**CWI Name:** Jesse Cayabyab**CWI Present:** Yes No**Inspected CWI report:** Yes No N/A**Rod Oven in Use:** Yes No N/A**Electrode to specification:** Yes No N/A**Weld Procedures Followed:** Yes No N/A**Qualified Welders:** Yes No N/A**Verified Joint Fit-up:** Yes No N/A**Approved Drawings:** Yes No N/A**Approved WPS:** Yes No N/A**Delayed / Cancelled:** Yes No N/A**Bridge No:** 34-0006**Component:** Tower ESW**Summary of Items Observed:**

Tower ESW "V"

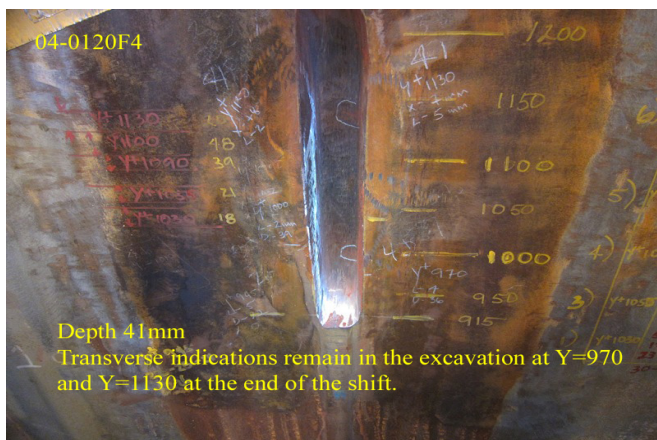
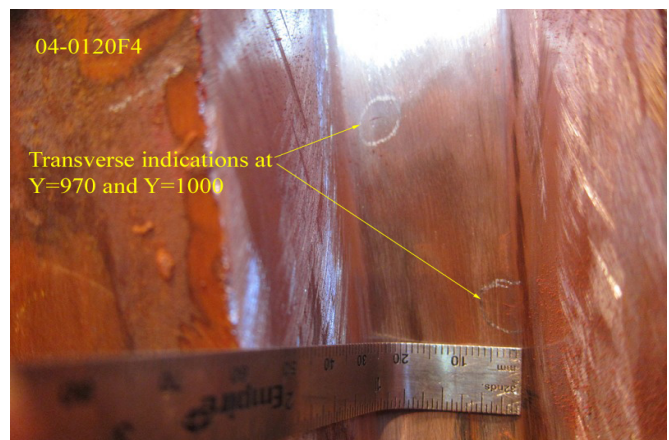
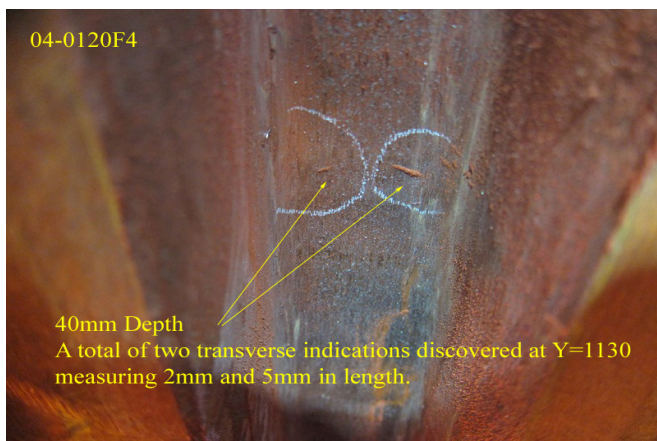
This QA observed ABF/JV welding personnel performing an exploratory excavation of an Electroslag Weld ESW "V" from face B. The exploratory excavation was performed to determine validity a 6db drop technique for the determination of height, on the linear recordable indications present in the electro slag welds. A total of six indications from the ultrasonic test report were excavated in one single excavation at 1~2mm intervals by the use of a grinder from Y=970~1220 for indications that showed the following ultrasonic response on the ABF QC test report;

36mm in depth– Transverse indication discovered at Y=970 measuring 6mm in length.

37mm in depth– Transverse indication at Y=970 remains 6mm in length.

38mm in depth– Transverse indication at Y=970 reduces to 3mm in length.

39mm in depth– Transverse indication at Y=970 reduces to 2mm in length. Transverse indication discovered at Y=1000 measuring 2mm in length.

40mm in depth– Unable to detect transverse indication at Y=1000. Indication at Y=970 remains 2mm in length. A total of two transverse indications discovered at Y=1130 measuring 2mm and 5mm in length.

41mm in depth–A total of two indications remain at Y=970 and Y=1130.
